Inspection Report

105 Dixie Dr.
Chapel Hill NC 27514

First Call Home Inspections LLC

Date: 3/21/2011	Time: 01:00 PM	Report ID: FC03230301
Property: 105 Dixie Dr. Chapel Hill NC 27514	Customer: Mr. John Cauthen	Real Estate Professional:

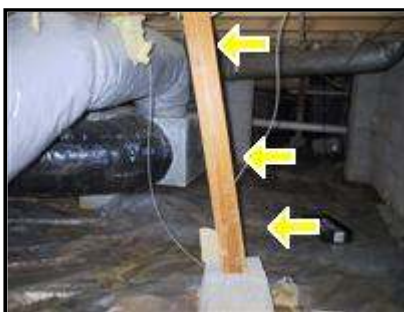
1.2 Picture 1

- A added structural support near the front of the home was leaning over and not secured. Secure the post to the floor to prevent the post from falling. Work should be done by a qualified contractor.

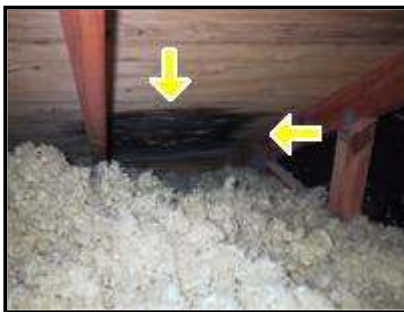
1.5 Picture 1

- The roof sheathing shows signs of staining on the front left corner of the home. The damage to this area is not significant to require replacing at this time. Recommend waiting until roof covering is replaced, so long as leak remains corrected. A moisture meter was used and indicated the leak was not active at the time of the inspection. A qualified contractor should repair as needed.

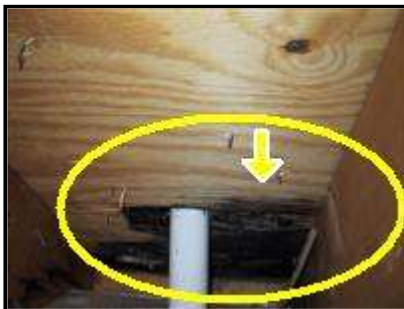
1.5 Picture 2

(2) The sheathing around the waste pipe on the back of the house showed signs of staining. The damage to this area is not significant to require replacing at this time. Recommend waiting until roof covering is replaced, so long as leak remains corrected. A moisture meter was used and indicated the leak was not active at the time of the inspection. A qualified contractor should repair as needed.

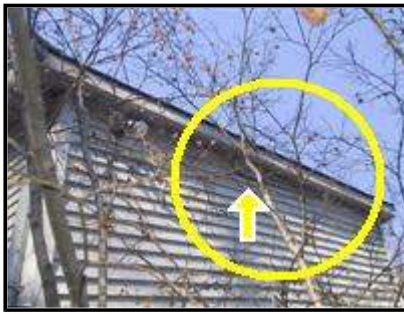
2.0 Picture 1

- A piece of siding needs to be secured to prevent any water from getting behind the siding. Location is the main section of the home on the right side up near the top of the home. Work should be done by a qualified contractor.

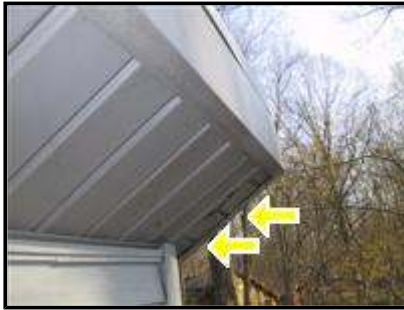
2.0 Picture 2

- A piece of trim on the front right section of the home needs to be adjusted to prevent insects and animal from getting behind the siding. Work should be done by a qualified contractor.

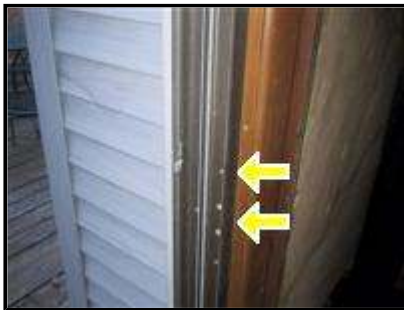
2.1 Picture 1

- The left sliding glass door in the living room is missing it's locking latch. This is considered unsafe and needs correcting. A qualified contractor should inspect and repair as needed.

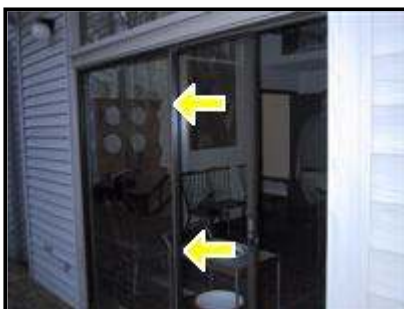
2.1 Picture 2

- Sliding glass doors at rear of home are missing there screens. One screen is in the lower crawlspace. This is a maintenance issue and is for your information..

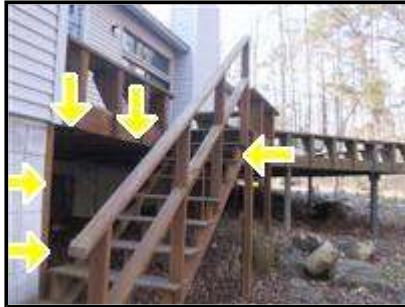
2.3 Picture 1

- The stairs at the back of the house leading up to the deck have spacing of more than 4 inches apart along the handrail on the both sides of the stairs and along the risers going up the stairs. This could allow an adult, child or pet to fall through. A qualified contractor should repair or replace as needed.

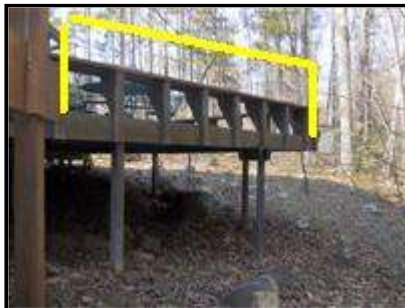
2.3 Picture 2

- The guardrails on deck at the rear of home are missing. The guardrail needs to be at least 36 inches tall. Also spacing more than 4 inches apart for the pickets could allow an adult, child or pet to fall through. A qualified contractor should repair or replace as needed.

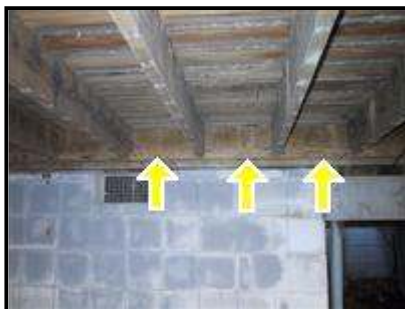
2.3 Picture 3

- The deck band is not attached properly to the wall of the home. It should have 5/8 galvanized "Lag Screws" or "Carriage Bolts" approximately every 20 inches. The potential of a deck collapse would be reduced if the bolts or screws were added. Work should be done by a qualified contractor.

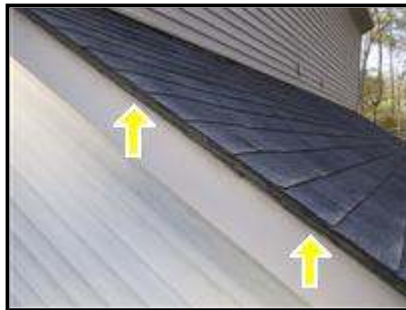
3.0 Picture 1

- The roof covering is old, and the life of covering will soon expired. The covering does need to be replaced. While it could last a year or so, some areas may need patching with tar as leaks develop. There are multiple layers of roofing which will need to be removed when roofing is done adding to the cost of the repair. Have a roofing contractor inspect the roof before closing.

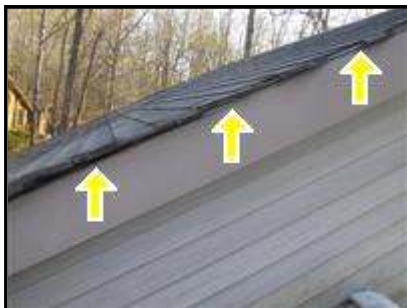
3.0 Picture 3

- The left edge of the roof line on the right section of the house is showing signs of deterioration. The shingles are cracking along the edge and the wood underneath has become exposed. Also a trim piece along the edge seems to be missing. Repairs and or replacement should be done by a qualified roofing contractor to prevent deterioration of the home.

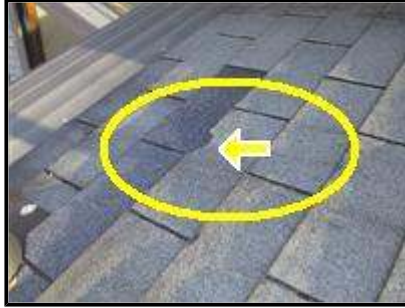
3.0 Picture 6

- A roof shingle is damaged at the rear of home above the washer/dryer room. It should be replaced as soon as possible to prevent water damage to the home. A qualified roofing contractor should inspect and repair as needed.

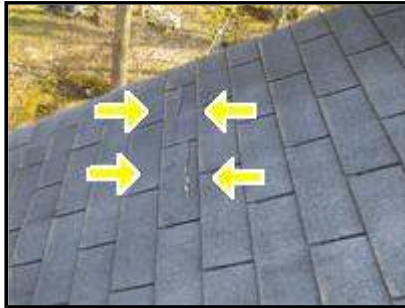
3.0 Picture 7

- Two roof shingles are cracked on the right side of the roof on the newer part of the home. The shingles are about half way up the roof line. They should be replaced as soon as possible to prevent water damage to the home. A qualified roofing contractor should inspect and repair as needed.

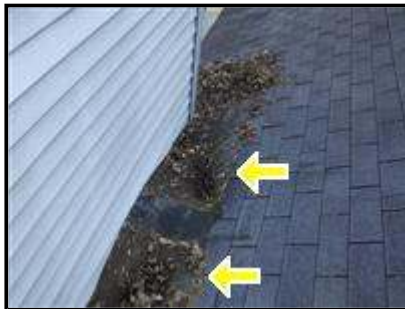
3.0 Picture 8

- Leaves and debris have and will accumulate behind the chimney on the back of the home. Clean the leaves from this area at least twice a year to prevent debris buildup.

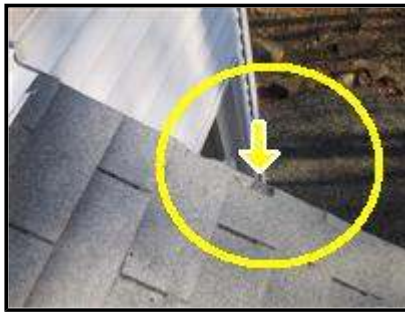
3.0 Picture 9

- A shingle is torn on the edge on the front right section of the home. This is above the bathroom on the right side of the home. Repairs or replacement should be done by a qualified roofing contractor.

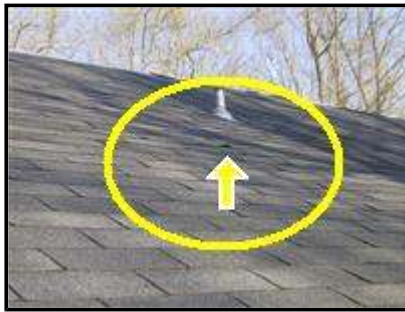
3.0 Picture 10

- One shingle is popping up on the center of the front main main roof. This could allow water to get underneath the shingle. Repairs should be done by a qualified roofing contractor.

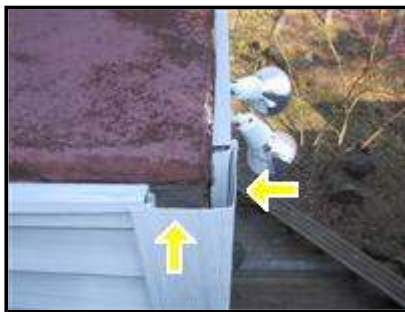
3.1 Picture 1

- Four corners around the chimney could have a cover placed over the exposed trim pieces to prevent water and debris from getting behind the siding. Work should be done by a qualified contractor.

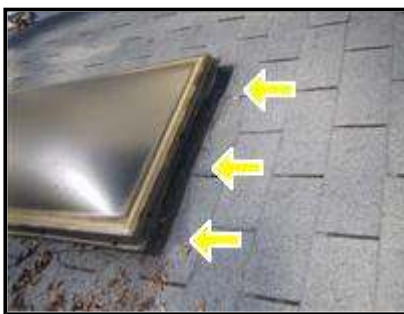
3.2 Picture 1

- The skylight over the main enter area is using caulking to prevent water from entering into the home. Proper flashing should be installed to prevent water intrusion. Possible leaks have occurred in the past indicated by drywall deterioration inside the home near the skylight. Any work should be done by a qualified contractor.

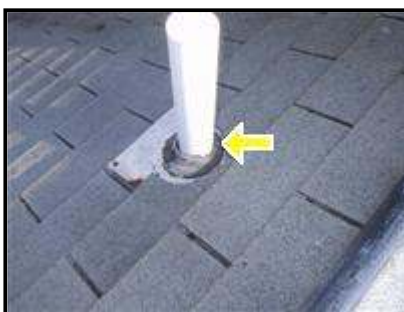
3.2 Picture 2

- The plumbing vent pipe (through roof) needs flashing boot replaced on the rear of home. It is the highest boot above the washer/dryer room. This area is leaking and needs to be repaired. A qualified roofing contractor should inspect further and correct as needed.

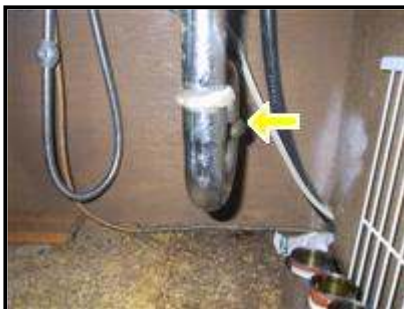
4.0 Picture 1

- The waste line is leaking at right side at the kitchen sink. Repairs are needed to stop leaking water from damaging the cabinet bottom or to eliminate moisture that may contribute to fungi growth. A qualified licensed plumber should repair or correct as needed.

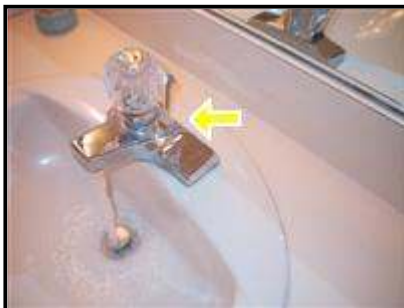
4.1 Picture 1

- The left sink faucets leaks at the back of the fixture at the upstairs bath. Repairs are needed to stop leaking water from damaging the cabinet bottom or to eliminate moisture that may contribute to fungi growth. A qualified licensed plumber should repair or correct as needed.

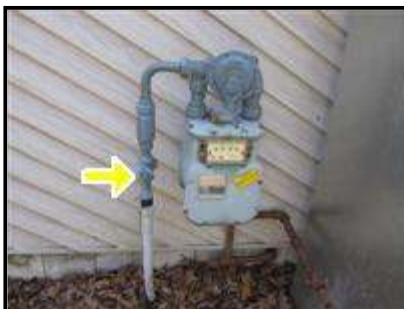
4.5 Picture 1

- The main fuel shut off is at gas meter outside on the left side of the home.

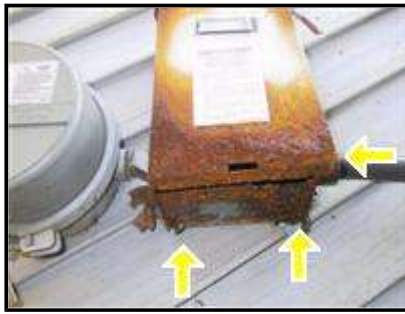
5.1 Picture 1

- The fuse disconnect box on the left side of the house for the air conditioner is rusted. The unit will need to be replaced to prevent animals from entering into the box. Work should be done by a licensed electrician.

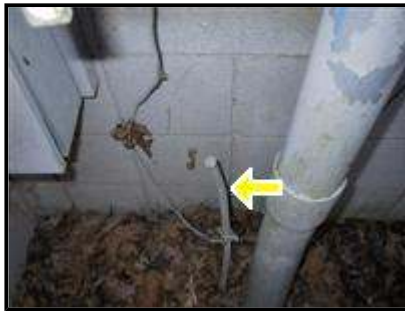
5.1 Picture 2

- A grounding rod at the back of the house has not been driving into the ground all the way. Further inspection is needed by a qualified licensed electrician. A qualified licensed electrician should correct as needed.

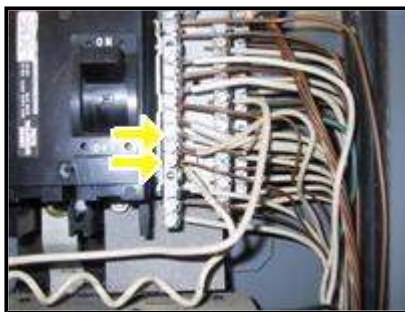
5.1 Picture 3

- At least two neutral and grounding wires are connected together on the grounding bar in the main electrical panel. These problems and any other problems that an electrician may discover while performing repairs need correcting. I recommend a licensed electrician inspect further and correct as needed.

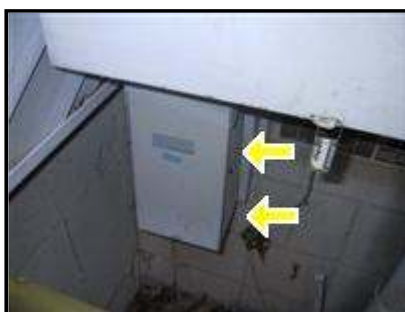
5.1 Picture 4

- This disconnect box below the main electrical box at the back of the home does not have the required 36 inch's of access space in front of the box. Proper access is needed in case repairs are needed to the electrical system. Repairs should be done by a licensed electrician.

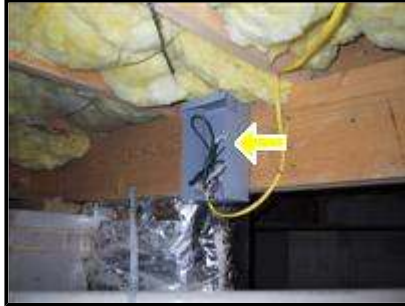
5.1 Picture 5

- A electrical connection box in the lower crawlspace is missing it's cover plate. The plate was found on the ground and needs to be installed by a qualified electrician for safety reasons.

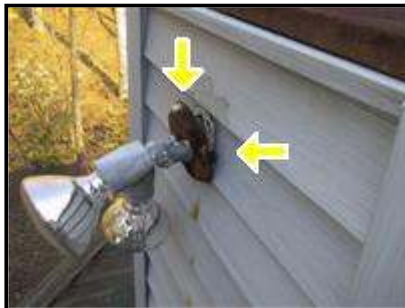
5.3 Picture 1

- The outside spot light on the right side of the chimney on the rear of the home is not secured properly to the wall. To prevent water from getting behind the fixture proper securing should be done by a licensed electrician.

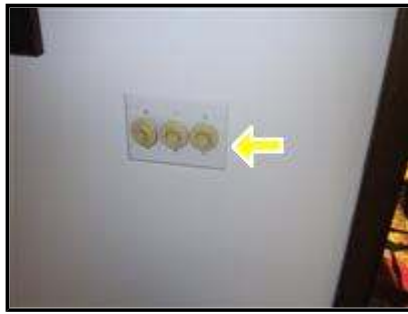
5.3 Picture 2

- Ask the home owner what all the switches are for in the main living room. Also the switch in the downstairs bedroom near the kitchen on the right wall.

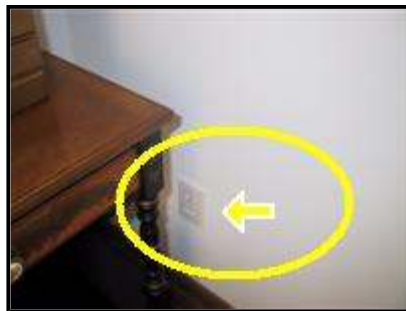
5.3 Picture 4

- The back left wall outlet in the downstairs bedroom closest to the kitchen is not grounded. Electrical issues are considered a hazard until repaired. A qualified licensed electrician should correct as needed.

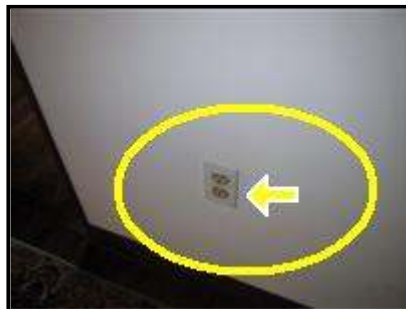
5.3 Picture 5

- The outlet on the wall between the dinning room and the kitchen is not grounded. Electrical issues are considered a hazard until repaired. A qualified licensed electrician should correct as needed.

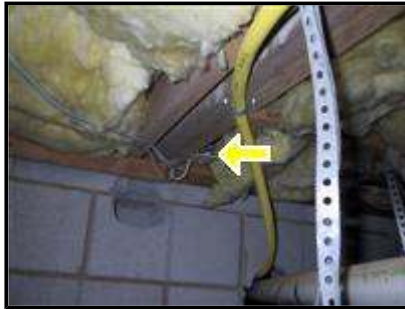
5.3 Picture 7

- A electrical connection box in the back right corner of the lower crawlspace is missing a cover plate. Adding a cover plate will prevent anyone from sticking object into the box. Work should be done by a qualified electrician.

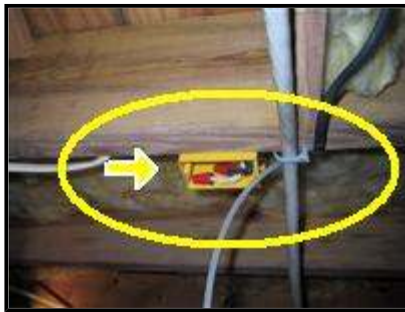
5.3 Picture 8

- A electrical connection box near the furnace in the upper crawlspace is missing a cover plate. Adding a cover plate will prevent anyone from sticking object into the box. Work should be done by a qualified electrician.

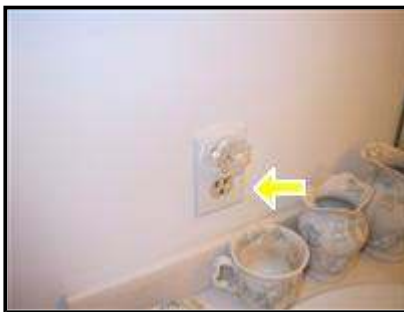
5.4 Picture 1

- One the upstairs bathroom was protected by a GFCI outlet. The other two bathroom were not GFCI protected. Repairs should be made by a licensed electrician.

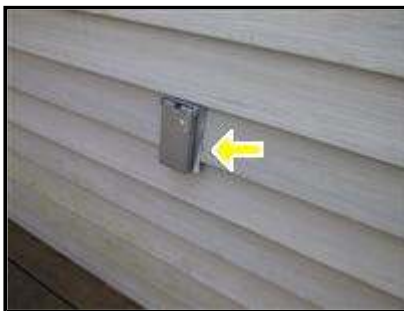
5.5 Picture 1

- GFCI (Ground Fault Circuit Interrupter) outlet at the back deck wont "trip" when tested. This is a safety issue that needs to be corrected. A qualified licensed electrician should perform repairs that involve wiring.

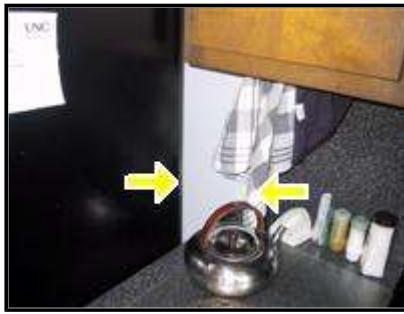
7.1 Picture 1

- FYI: The refrigerator will not slide up against the wall in the kitchen. This is because the freezer door will not open when the unit is up to the wall.

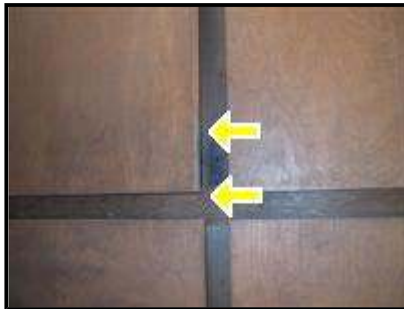
7.4 Picture 1

- The left top cabinet on the right side of the kitchen does not close well and needs to be adjusted for proper operation. Work should be done by a qualified contractor.

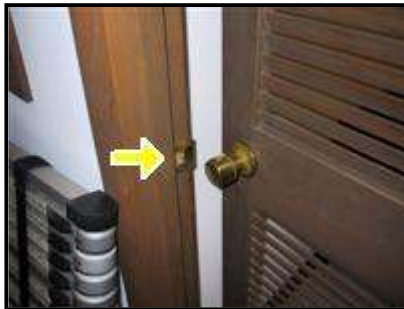
7.5 Picture 1

- The laundry room door would not latch. Adjustment is needed by a qualified contractor for proper operation.

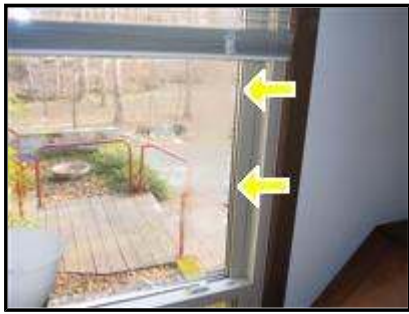
7.6 Picture 1 dining room top right

- A few windows on the south side of the house have lost their seal and have condensation in them. One window has a crack. All windows are on the right side of the home. Replacement of these windows may be necessary. Have a qualified window contractor inspect and replace as needed.
- (Picture 1) Dining room top right window.
- (Picture 2) Right bedroom upstairs, top right window has a crack on the bottom left corner.
- (Picture 3) Right bedroom upstairs, bottom right window.
- (Picture 4) Right bedroom upstairs, top left window.

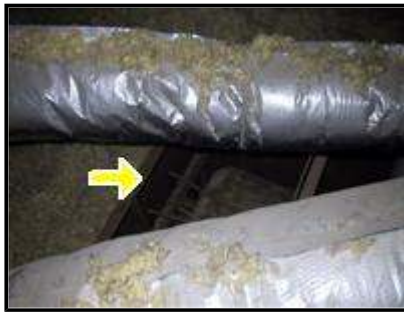
8.3 Picture 1

- The area above the upstairs bathroom needs to be insulated to prevent heat and cooling loss. Work should be done by a qualified contractor.

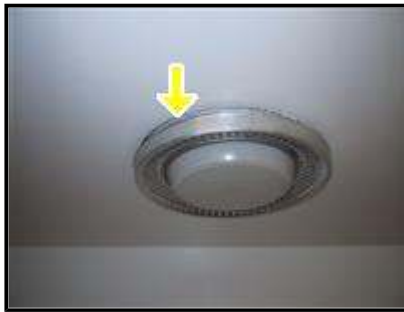
8.4 Picture 1

- The exhaust fan is loose and not securely mounted to the ceiling in at the right bathroom on the main level. This is a safety issue that needs repair. A qualified contractor should inspect and repair as needed.

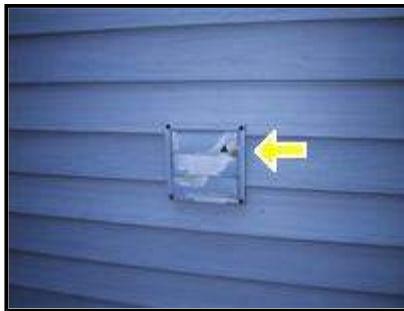
8.4 Picture 2

(2) The dryer vent cover at the back deck is broken on the right top corner. Replacement may be necessary to prevent insect and animals from entering into the structure. Work should be done by a qualified contractor.

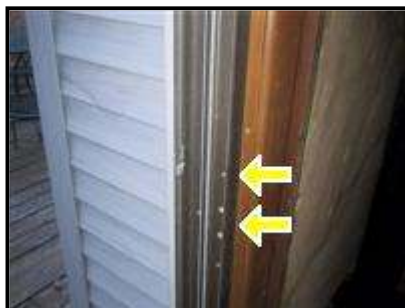
- The left sliding glass door in the living room is missing it's locking latch. This is considered unsafe and needs correcting. A qualified contractor should inspect and repair as needed.

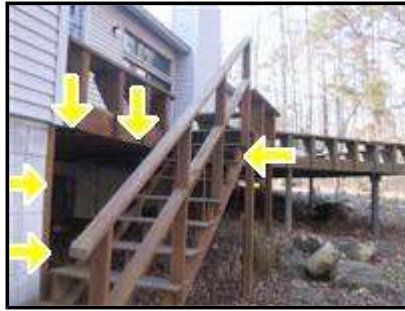
2.3 Picture 1

- The stairs at the back of the house leading up to the deck have spacing of more than 4 inches apart along the handrail on the both sides of the stairs and along the risers going up the stairs. This could allow an adult, child or pet to fall through. A qualified contractor should repair or replace as needed.

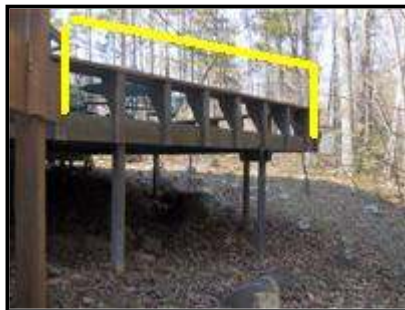
2.3 Picture 2

- The guardrails on deck at the rear of home are missing. The guardrail needs to be at least 36 inches tall. Also spacing more than 4 inches apart for the pickets could allow an adult, child or pet to fall through. A qualified contractor should repair or replace as needed.

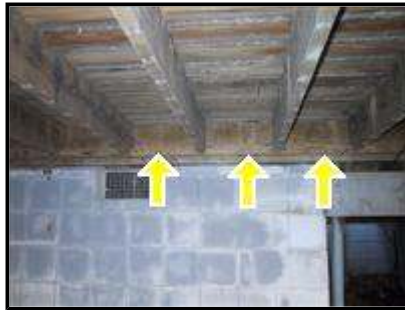
2.3 Picture 3

- The deck band is not attached properly to the wall of the home. It should have 5/8 galvanized "Lag Screws" or "Carriage Bolts" approximately every 20 inches. The potential of a deck collapse would be reduced if the bolts or screws were added. Work should be done by a qualified contractor.

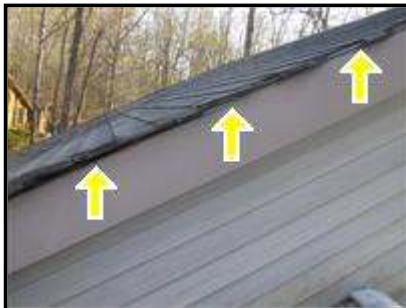
3.0 Picture 3

- The left edge of the roof line on the right section of the house is showing signs of deterioration. The shingles are cracking along the edge and the wood underneath has become exposed. Also a trim piece along the edge seems to be missing. Repairs and or replacement should be done by a qualified roofing contractor to prevent deterioration of the home.

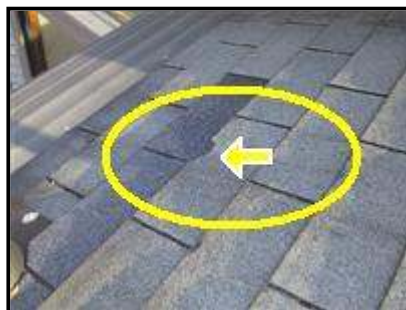
3.0 Picture 6

- A roof shingle is damaged at the rear of home above the washer/dryer room. It should be replaced as soon as possible to prevent water damage to the home. A qualified roofing contractor should inspect and repair as needed.

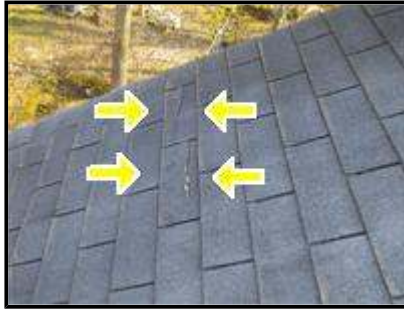
3.0 Picture 7

- Two roof shingles are cracked on the right side of the roof on the newer part of the home. The shingles are about half way up the roof line. They should be replaced as soon as possible to prevent water damage to the home. A qualified roofing contractor should inspect and repair as needed.

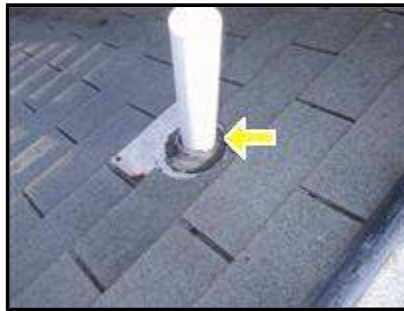
3.2 Picture 2

- The plumbing vent pipe (through roof) needs flashing boot replaced on the rear of home. It is the highest boot above the washer/dryer room. This area is leaking and needs to be repaired. A qualified roofing contractor should inspect further and correct as needed.

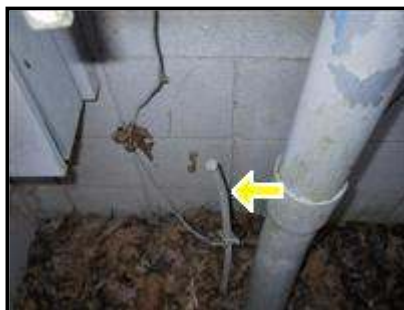
5.1 Picture 2

- A grounding rod at the back of the house has not been driving into the ground all the way. Further inspection is needed by a qualified licensed electrician. A qualified licensed electrician should correct as needed.

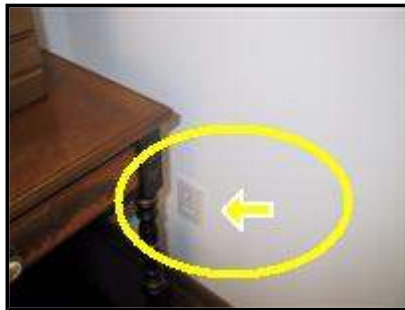
5.3 Picture 4

- The back left wall outlet in the downstairs bedroom closest to the kitchen is not grounded. Electrical issues are considered a hazard until repaired. A qualified licensed electrician should correct as needed.

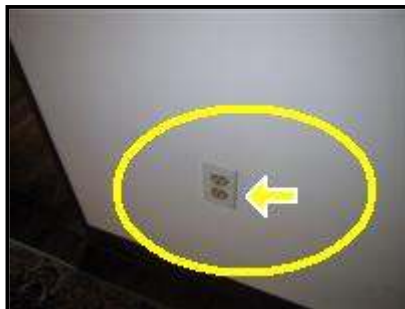
5.3 Picture 5

- The outlet on the wall between the dinning room and the kitchen is not grounded. Electrical issues are considered a hazard until repaired. A qualified licensed electrician should correct as needed.

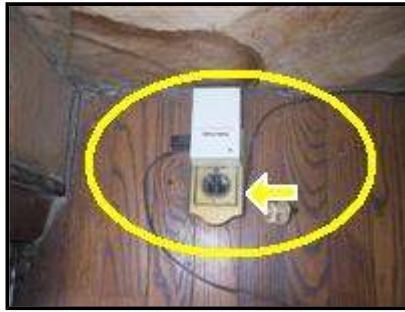
5.3 Picture 6

issues are considered a hazard until repaired. A qualified licensed electrician should correct as needed.

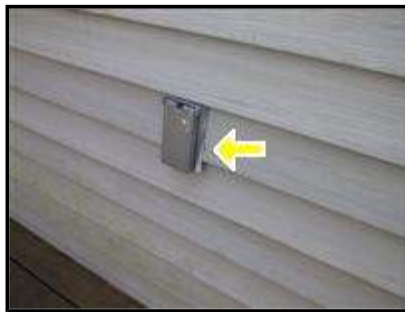
5.5 Picture 1

- GFCI (Ground Fault Circuit Interrupter) outlet at the back deck wont "trip" when tested. This is a safety issue that needs to be corrected. A qualified licensed electrician should perform repairs that involve wiring.

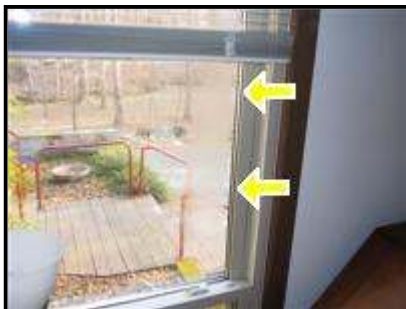
7.6 Picture 1 dining room top right

- A few windows on the south side of the house have lost there seal and have condensation in them. One window has a crack. All windows are on the right side of the home. Replacement of these windows may be necessary. Have a qualified window contractor inspect and replace as needed.
- (Picture 1) Dining room top right window.
- (Picture 2) Right bedroom upstairs, top right window has a crack on the bottom left corner.
- (Picture 3) Right bedroom upstairs, bottom right window.
- (Picture 4) Right bedroom upstairs, top left window.

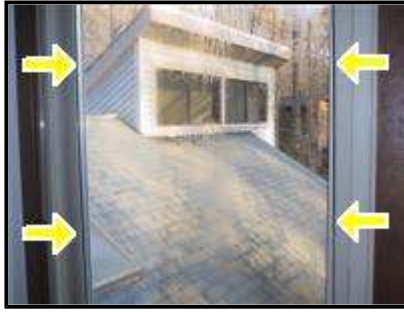
7.6 Picture 4 Upstairs top left window
